## DYNAMIC TESTS OF AN ENERGY ABSORBING BARRIER EMPLOYING WATER-FILLED PLASTIC CELLS

70-08

**NO. M & R 636405-3**

November 1970  
M&R No. 636405-3  
Final ReportMr. J. A. Legarra  
State Highway Engineer

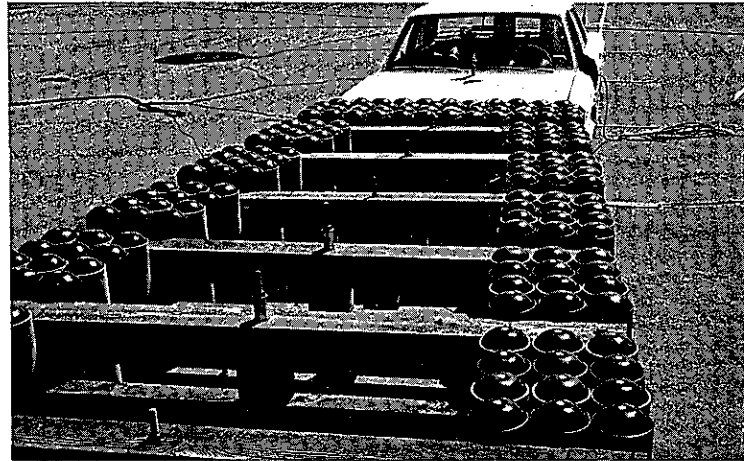
Figure 1

Results: See Plate 1 (page 11) for a summary of the test results. A 4680 lb. Dodge impacted the test barrier headon at a speed of 14.7 mph. The crash vehicle came to a relatively smooth stop while sustaining no damage. Vehicle rise was three inches. There was no measurable deformation of the steering wheel. Maximum penetration of the crash vehicle into the barrier was five feet. The post impact position of the leading edge of the barrier was 4'-1" behind its pre-impact position. The barrier was undamaged. The weight of water expelled from the cells was 922 lbs.

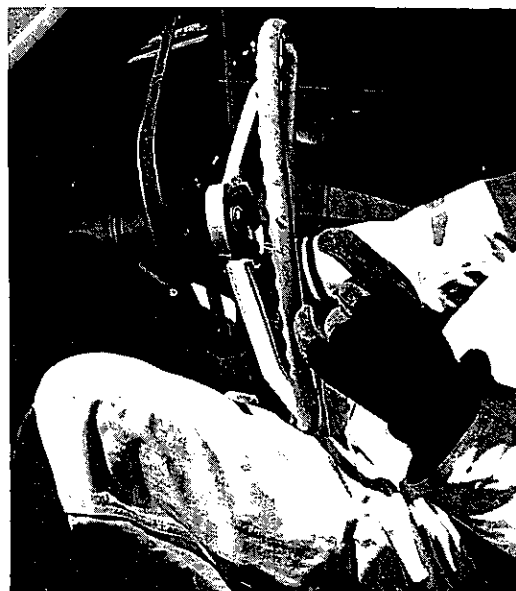
Figure 4

Results: See Plate 2 (page 14 ) for a summary of the test results. A 4680 lb. Dodge impacted the test barrier headon at a speed of 33.3 mph. The test vehicle did not stop quite as smoothly as it did for Test 211. Vehicle rise was 4-1/2 inches. Damage to the vehicle was moderate and included deformation of the grill, front bumper, and front of the hood (see Figure 2, below). The exhaust manifold was broken near its attachment to the engine block and the radiator was forced back into the V-belt lower pulley. The post behind the front door (removed for the test) on the drivers side failed at its connection with the roof (see Figure 3, below). The permanent deformation of the steering wheel was 2" (see Figure 4, below).

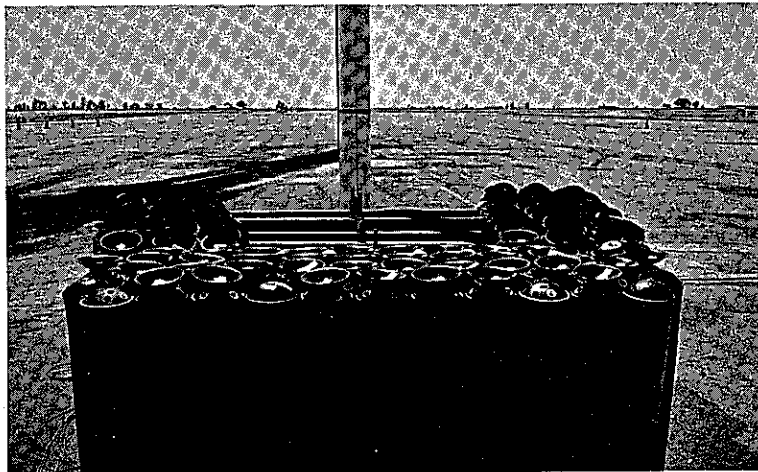
Figure 5

Only minor damage was sustained by the barrier (see Figure 5, below). Four evaporation caps were blown off water cells in the nose cluster and some crosby clips on the guide cable were jammed against the cable guide in diaphragm No. 5. The concrete backstop was shifted back one inch. Maximum vehicular displacement of the barrier was 8'-4"; the post impact location of the leading edge of the barrier was 6'-6" behind its pre-impact position. A total of 2250 lbs. of water was expelled from the cells.

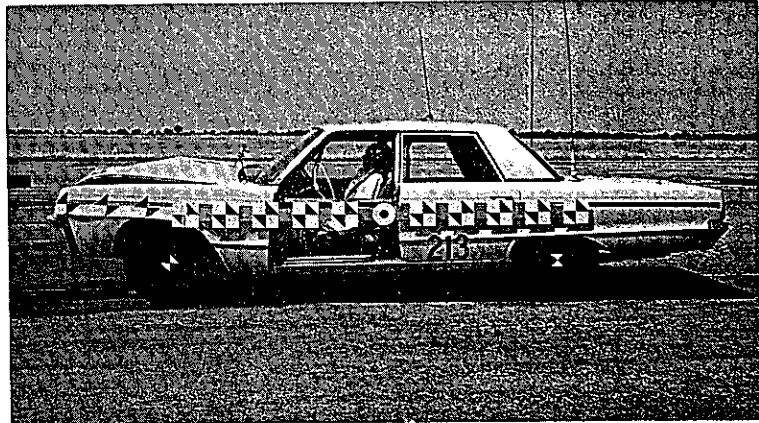
Figure 8

Results: See Plate 3 (page 18 ) for a summary of the test results. A 4600 lb. Dodge impacted the test barrier headon at a speed of 48.2 mph. During impact, the vehicle rode up on the barrier nose. Vehicle rise was 11 inches. The vehicle fan and radiator were jammed up against the engine block. There was severe damage sustained by the grill, front bumper, and front of the hood of the test vehicle (see Figure 7, below). The body of the vehicle was deformed over the door post and in front of the front door hinges on both sides, indicating a severe buckling failure of the vehicle chassis (see Figure 8, below). There was severe buckling of the right front fender

and minor buckling of the left front fender. There was moderate buckling of the floor board in the rear of the passenger compartment. The impact force of the dummy, restrained by both a lap belt and single diagonal shoulder harness, caused a 2-1/2 inch permanent deformation in the steering wheel. The driver's seat came loose on its guides although the guides remained firmly attached to the floorboard. There was some fraying of the shoulder harness near its connection to the lap belt. The vehicle was considered a total loss.

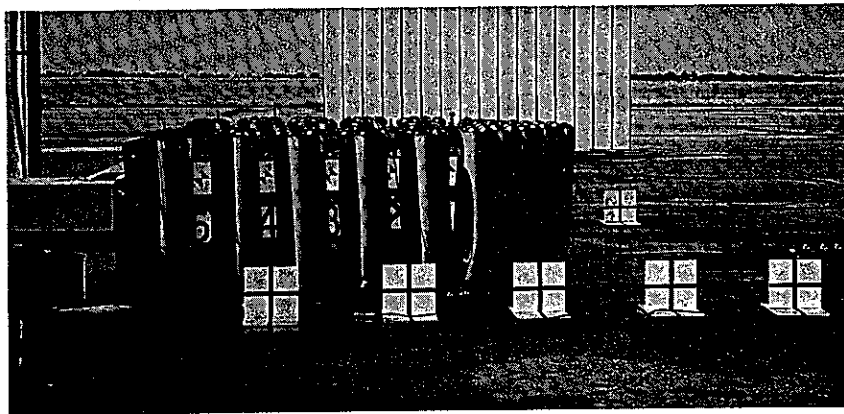
Figure 9

Barrier damage consisted of 26 orifice plugs ejected, a deformed "through" bolt at the left end of Diaphragm No. 6, splitting of the left end of the middle 6" x 6" timber on Diaphragm No. 6, and one broken pressure transducer (see Figure 9, below). Maximum vehicular displacement of the barrier was 12'-5". The post impact position of the leading edge of the barrier was 6'-2" behind its pre-impact location.

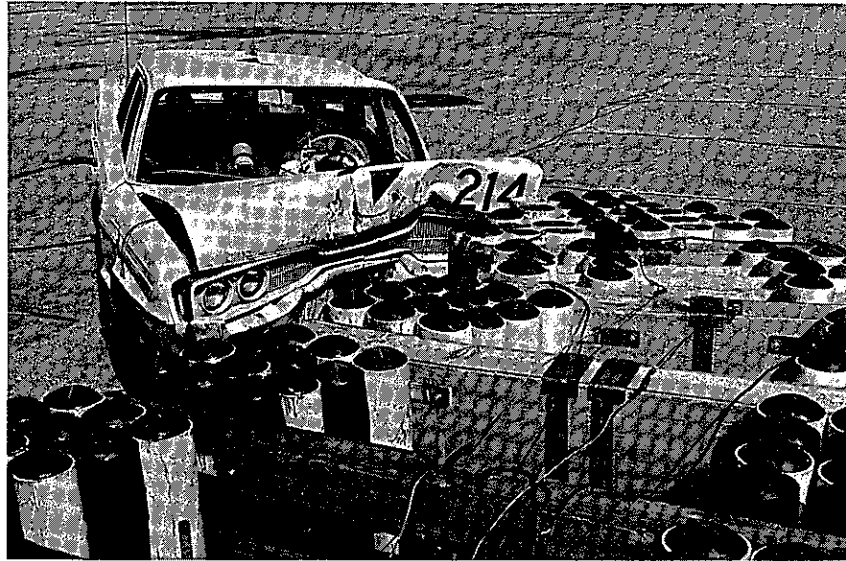
Figure 13

The barrier was twisted such that the center of the nose was displaced 3 ft. back and 2 ft. to the right of its original position (see Figure 13, below). Barrier damage consisted of separation between four pairs of cells, bending and crushing failures of Diaphragm Nos. 1, 2, and 3, splitting of spacer blocks in Diaphragms 4 and 5, failure of the legs of all three 5/8 inch plywood panels,

and failure of all the components of the "rigid" backstop. The most significant failure was of the center cable attachment to its front anchor. Slipping of the "dead" end of the cable through the cable clips was the cause of failure. Although the number and spacing of the clips was less than the industry's recommendations (due to the proximity of the barrier nose with the anchor), this same system sustained over 6000 lbs. of tensile load during Test 213. This cable failure did significantly alter the barrier performance after cable slip occurred. Also, the turnbuckle strain gage data indicates that the 4000 lb. cable preload was, for some unexplained reason, lost prior to impact. This also altered the barrier's resistance to upward movement.

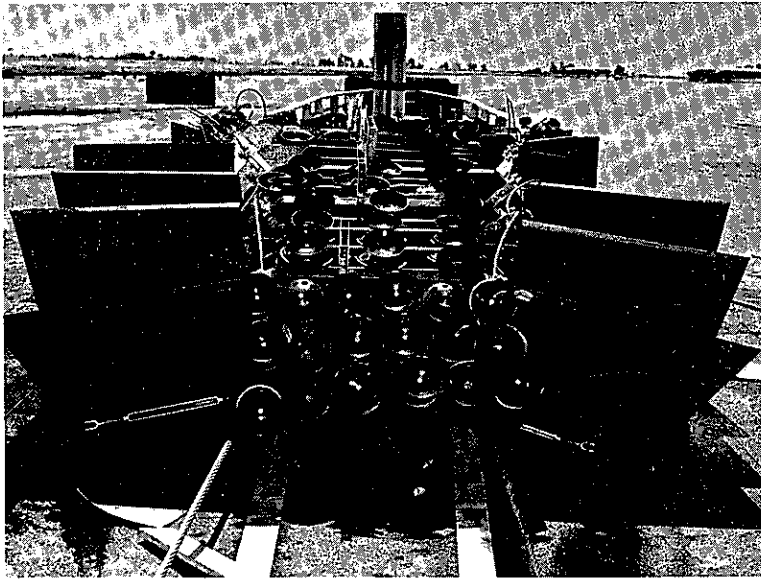
Figure 22

The barrier remained intact; however, some damage was sustained (see Figure 22, below). Many of the fender panels were scarred and most were damaged on the rear bottom corners where they were thrust into the ground as the barrier was compressed (see Figure 23, below). The edges of several diaphragms were broken or showed delamination of the plywood; hinges between fender panels and diaphragms were bent or broken in several locations. Damage was less severe towards the rear portion of the barrier. Interior panels were undamaged behind the void module (third section back of the nose). There was no damage to the steel backup structure. Barrier displacement was 9.3 feet.

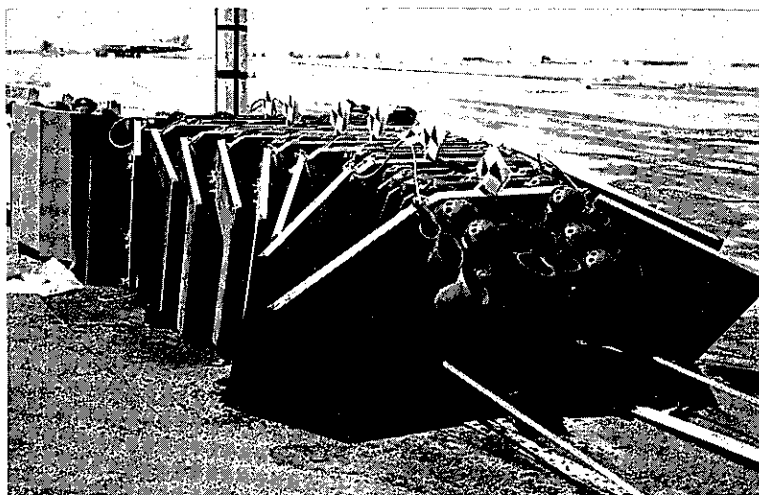
Figure 27

No barrier components were dislodged. Fender panels on the left side of the first three modules were scarred. Bottoms and/or top inserts were blown out of 16 water cells. The shear pins on the front secondary cables were sheared off. The barrier as a whole was translated straight back with negligible lateral movement or "buckling". Maximum vehicular displacement of the barrier was 16.3 feet but the permanent displacement of the barrier nose was only 10.7 feet (see Figure 27, below).

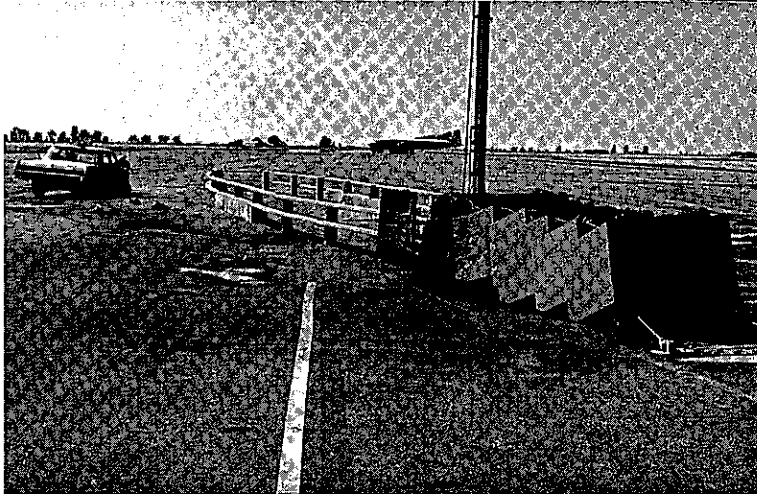
Figure 29

Several fender panels were torn off the barrier on the left side, mainly due to hinge failures. Two panels were thrown 8'-0" beyond the final position of the car and two panels were lodged in the crushed front end of the car. The five cells on the left side

of the bridge approach guardrail were all torn off and scattered along the path of the car. Shear pins in the secondary cables sheared off. Permanent displacement of the barrier nose was 1.5 feet (see Figures 29 and 30, below).

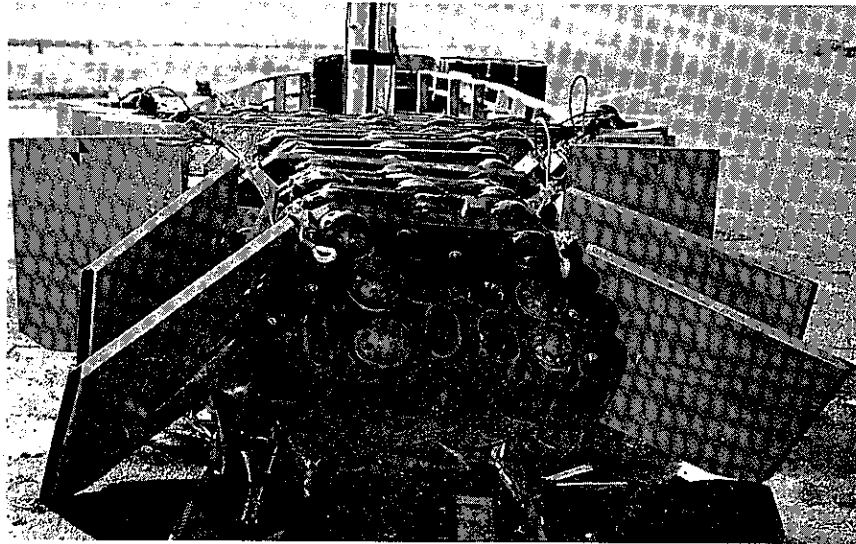
Figure 32

Maximum vehicular penetration was 15.3 feet and permanent displacement of the barrier nose was 11.7 feet. There was delamination and splitting of some of the interior panels and diaphragms, bent and broken hinges, and gouging of some of the fender panels; however, no parts became detached from the barrier (see Figure 32, below).
